Department of Water Resources

BULLETIN No. 116-5

THE ALASKAN EARTHQUAKE

OCTOBER 1965

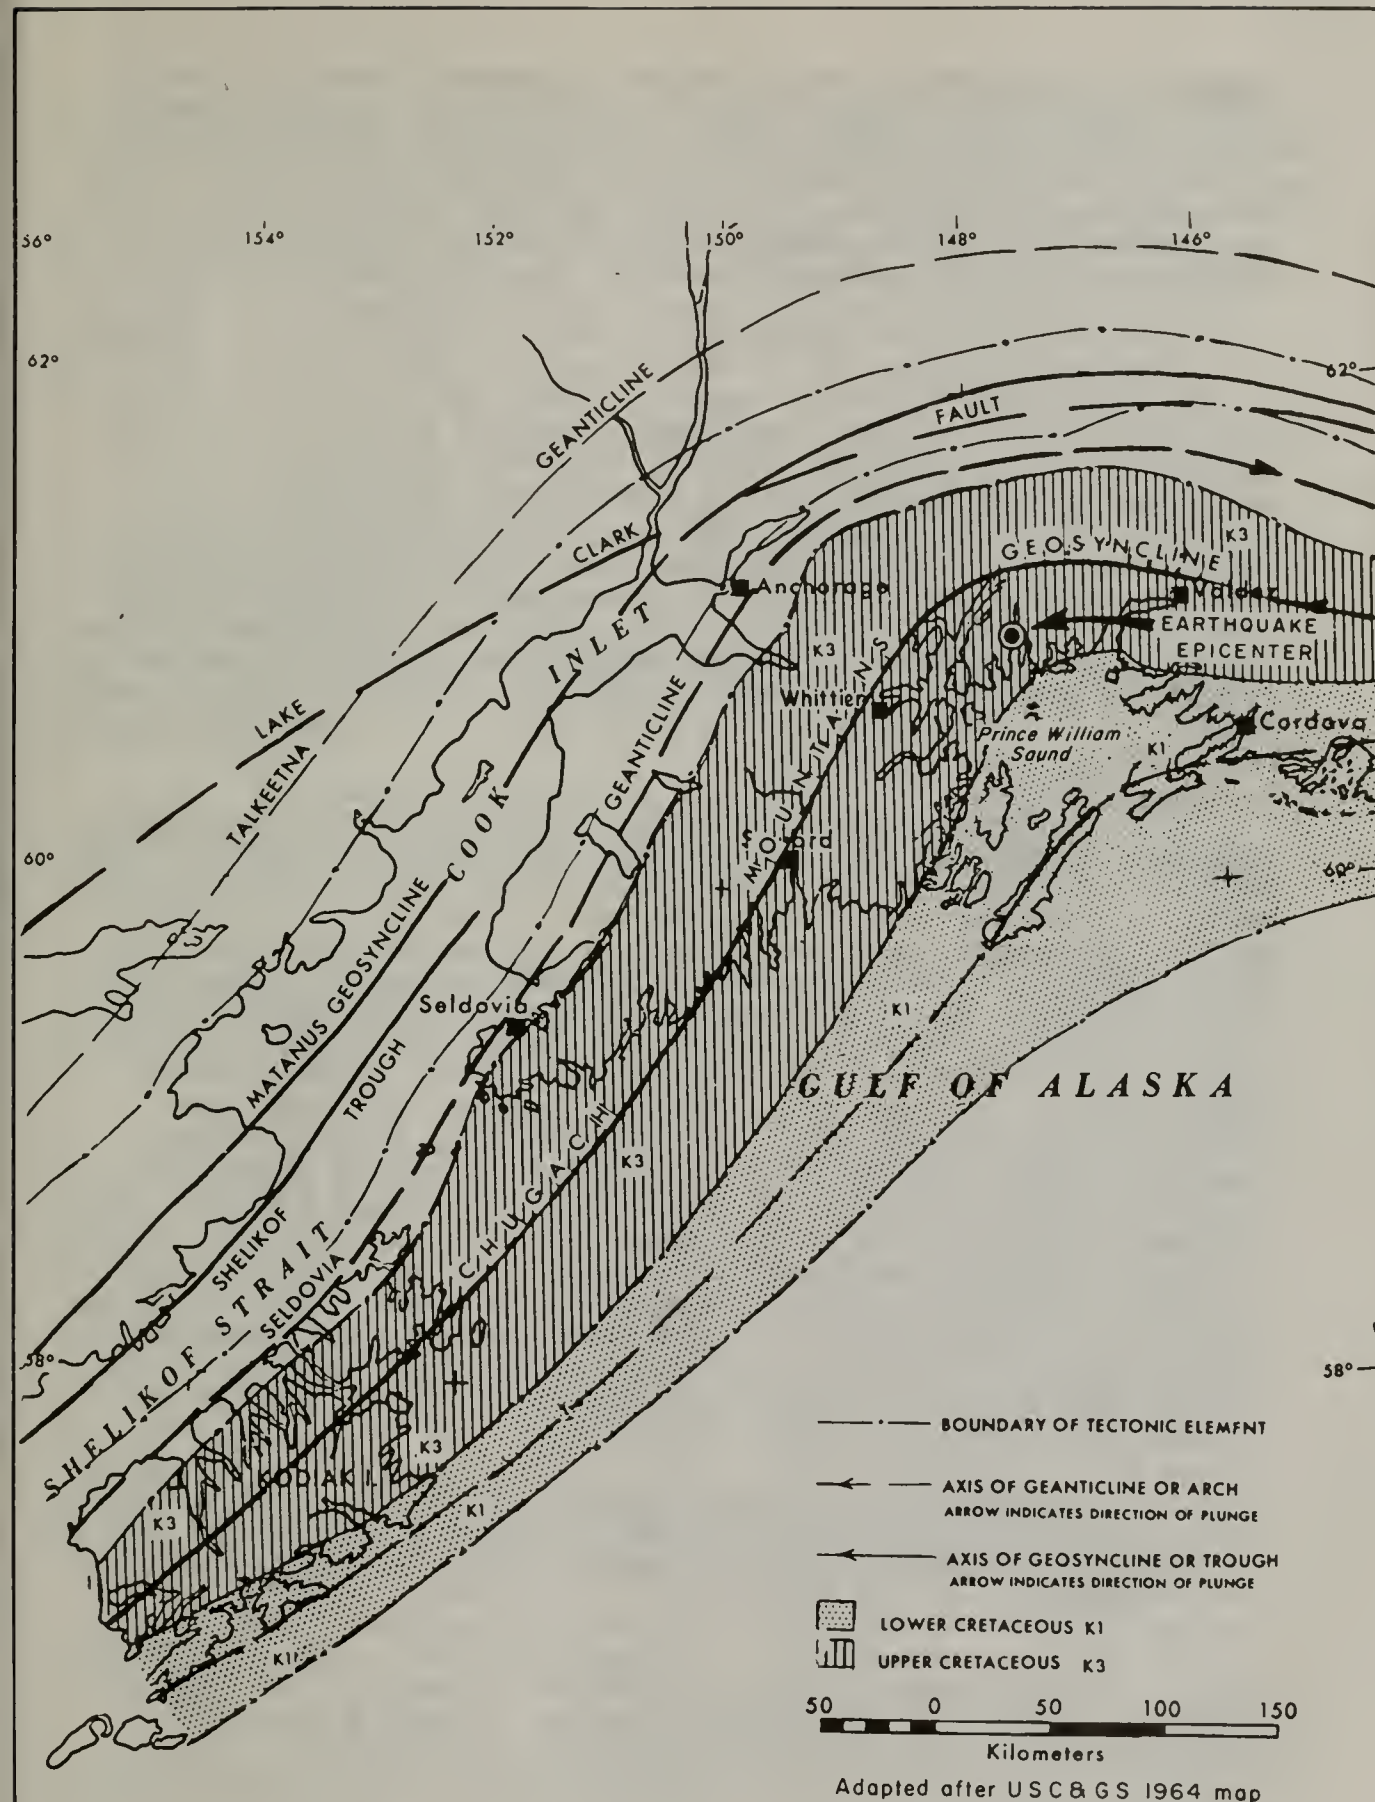
TECTONIC MAP OF THE EPICENTRAL AREA

formed of sedimentary rocks folded in geosynclinal and geanticlinal structures. Major faults parallel the axes of these major folds in the earth's crust. On the east side of the Gulf of Alaska the general trend of major geologic structures is to the northwest. As shown in Figure 2, these major geologic structures bend around Prince William Sound to a southwest trend, merging with the structural trend of the Aleutian Islands.

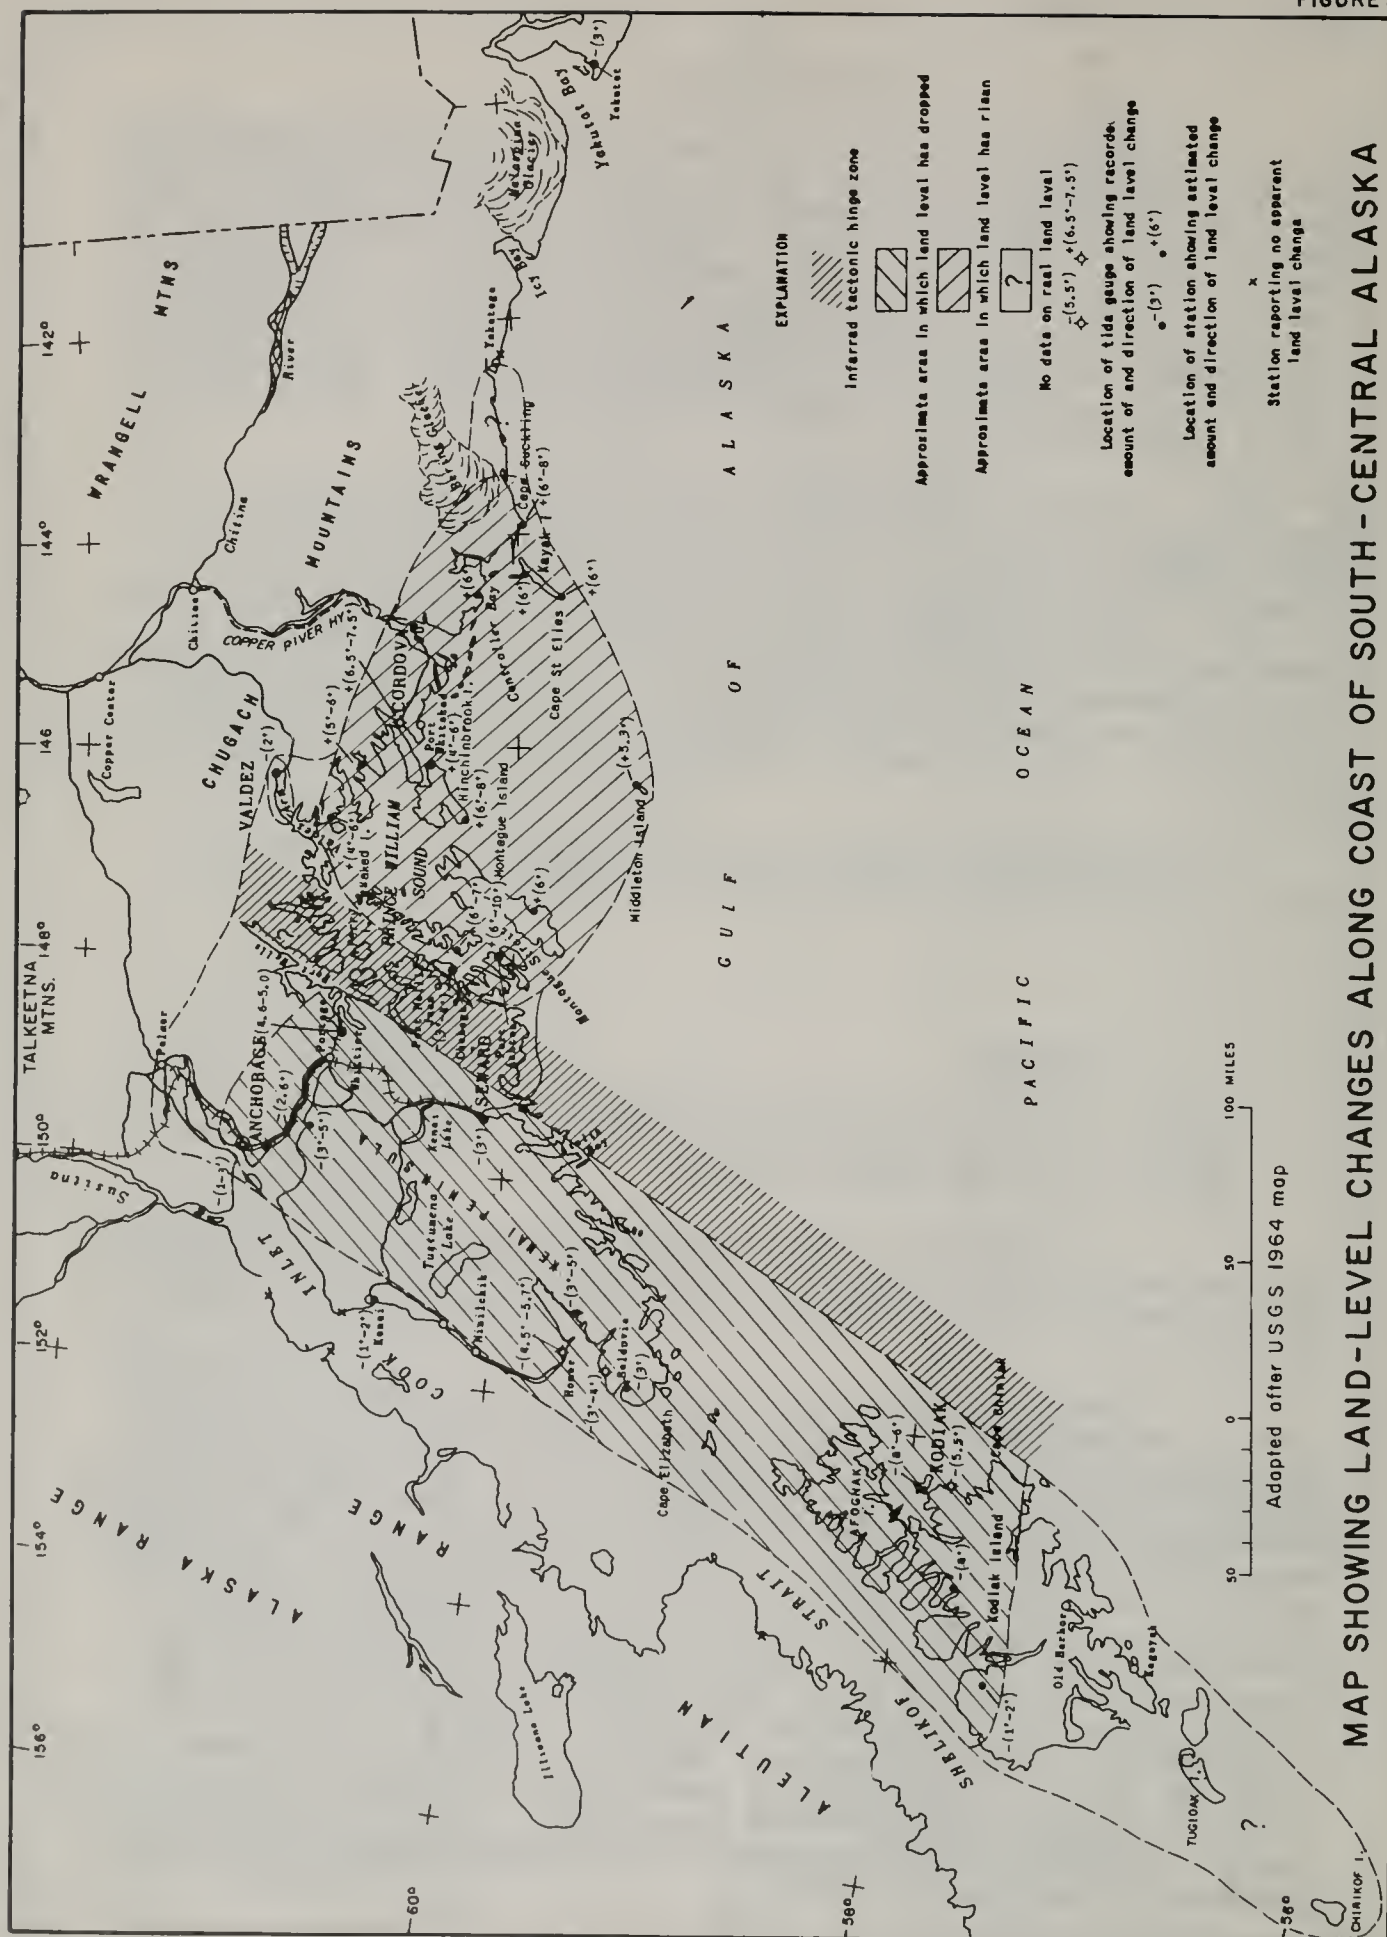
Preliminary estimates by the U. S. Geological Survey indicated that 34,000 square miles of the earth's crust was affected by tectonic uplift or subsidence. The original estimate of the area is shown on Figure No. 5. From subsequent studies, not yet concluded, it appears that an area of approximately 600 miles long and 20 to 60 miles wide on the north side of the trench was depressed and an area of approximately 600 miles long and up to 100 miles wide on the southerly side of the trench was uplifted. Rough estimates indicate that approximately 43,000 square miles were affected by subsidence, and 40,000 square miles affected by uplift, making a total affected area of 83,000 square miles, equivalent to approximately half the area of the State of California. Maximum tectonic subsidence indicated by the tide gages was 5.6 feet at Womans Bay on Kodiak Island; whereas maximum tectonic uplift of 33 feet was measured on Montague Island.
